Confidential Inspection Report
1234 NE Might Buy This Property
Unknown, OR

Prepared for: Potential Buyer

Prepared by: Inspectek West, Inc.
13703 NW Mill Creek Dr.
Portland, OR 97229
503.799.7761 tincup363@hotmail.com

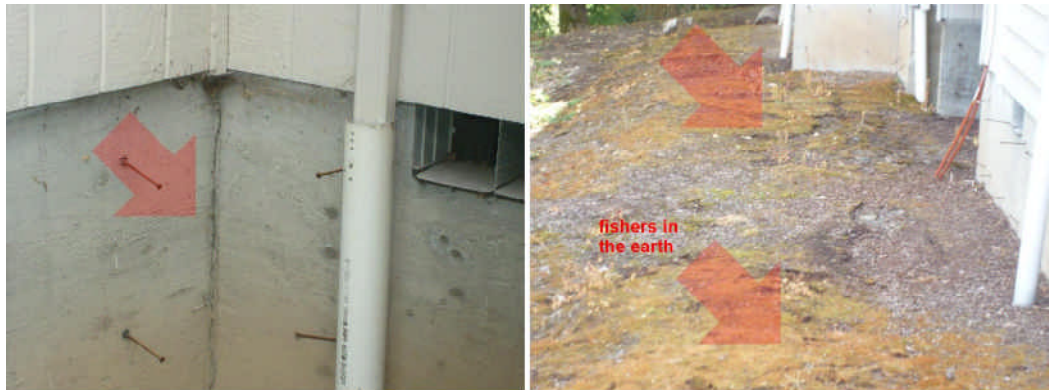
Major structural cracks were noted at the following areas; North elevation of building #4153. Large fishers in the earth are also noted at this same area and could be leading to movement of the building. These fishers show signs of obvious geological movement. We advise further evaluation by **a structural engineer** to ensure the integrity of the structure for building #4153. Additionally building #4145 has several posts and piers where the angle of repose for the grade puts the posts at risk during seismic movement; these should also be evaluated by a structural engineer.

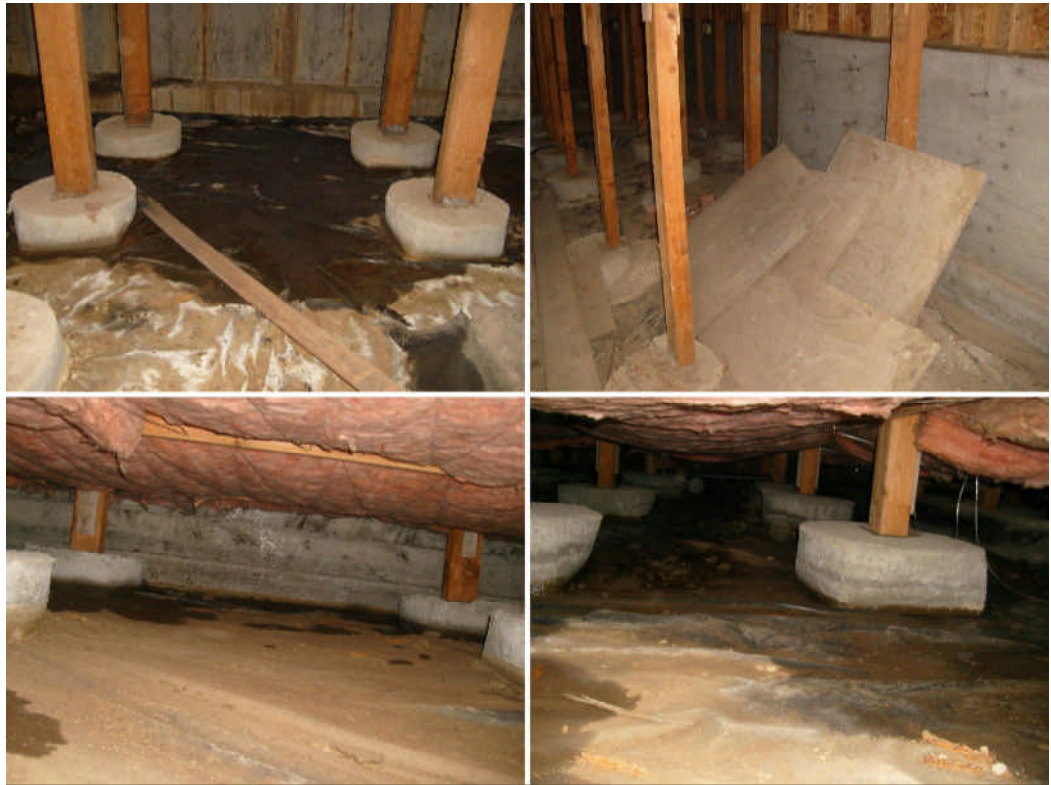
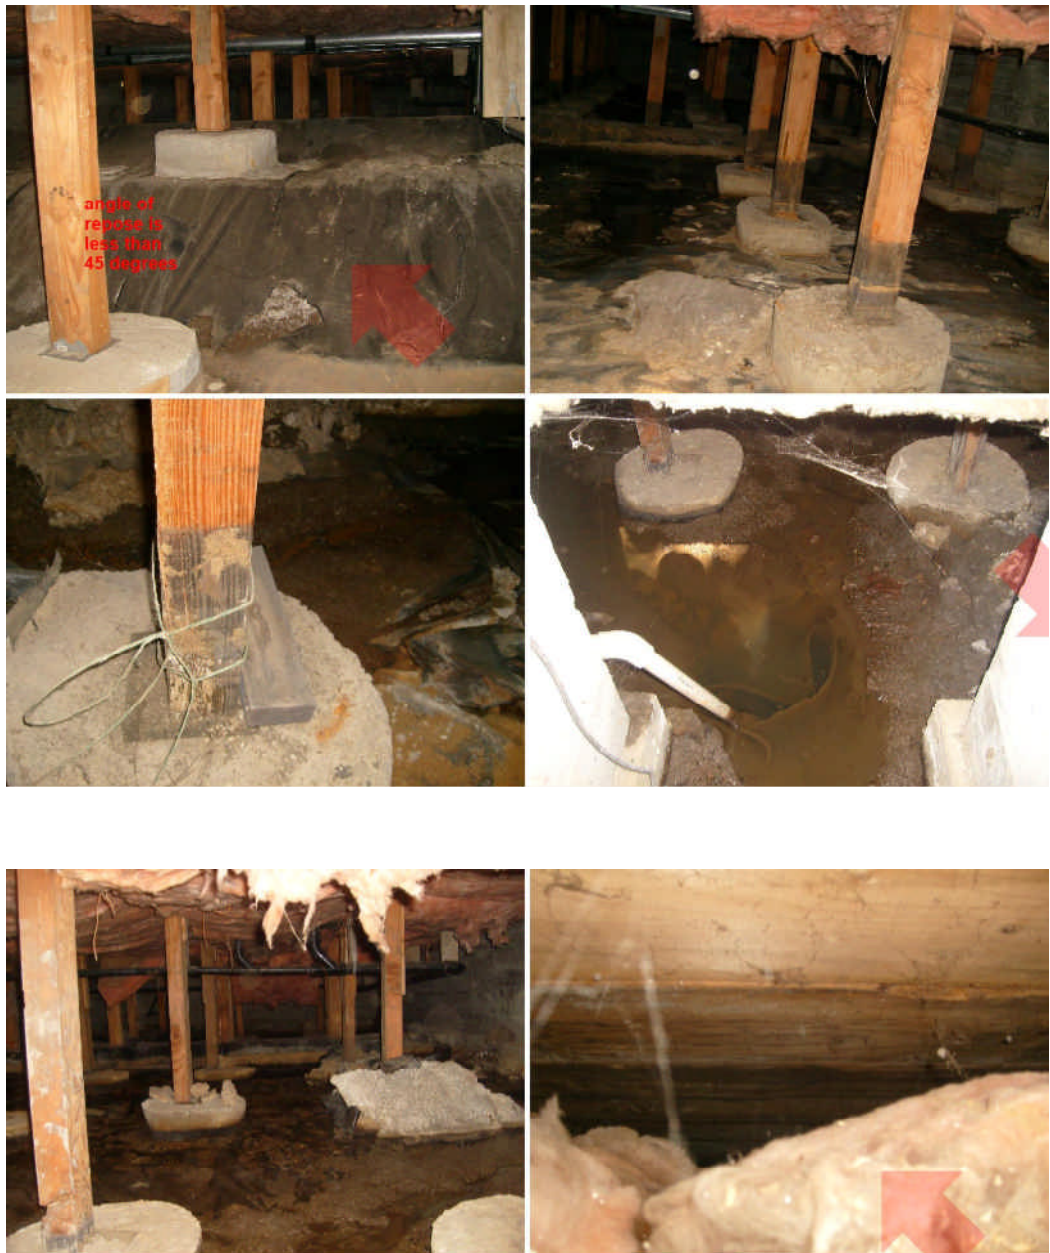
Every crawlspace was inspected. Each crawlspace has two different accesses, with a concrete foundation wall separating the two sides. Each crawlspace had insulation up under all the floors, in the rims and sills, which only allows for spot checks for wood destroying organisms. Our comments are based on the conditions at the time of the inspection. Any issues or repairs noted in this report should be evaluated and repaired by a licensed professional. Every crawlspace showed signs of **dead carpenter ants**, located in the corners in cobwebs as well as other locations. Some live ants were also found in the crawl spaces. We recommend that buyer budget for a pest application on all the buildings prior to purchase. The other issues found in each crawlspace are as follows; **Building 4131**: Bulk water noted in crawlspace. Current standing water. Needs to have a drainage contractor evaluate and provide a positive drain system to keep the crawl space dry at all times. The subfloor condition is not known and would require removal of all insulation to fully inspect for mold and mildew issues. Remove water and have re-inspected. **Building 4133**: Remove wood debris, re-stretch vapor barrier and re-hang fallen insulation. **Building 4135**: Remove wood debris, re-stretch vapor barrier and re-hang fallen insulation. **Building 4137**: Remove wood debris, re-stretch vapor barrier and re-hang fallen insulation. **Building 4139**: Remove nested animal in crawlspace. re-screen all open foundation vents. Dryer ducts have become disconnected. Remove all lint and reconnect the ducts. Remove all wood debris and re-hang fallen insulation. **Building 4141**: Re-stretch vapor barrier. Remove dead carcass and wood debris left in the crawlspace. Re-screen all open foundation vents. North access has a nested animal that needs to be removed. Nested animal makes the North elevation inaccessible, safety is an issue. Remove animal and have re-inspected. Re-hang insulation; and wiring that lays on ground needs to be re-secured up off the floor. **Building 4143**: 100 percent Bulk water is noted throughout the crawlspace. 5-6" deep of water. Non-working sump pump is noted, recommend replacement of the sump pump to insure that bulk water is removed from the crawl space at all times.. Approx. 30-40

percent of the 4x4 support posts have sustained rot damage and are in need of immediate replacement. Insulation was pulled back at a few different areas and mold/mildew was noted to the underside of the subfloor. We recommend that all the insulation be yarded out under this crawlspace and be checked thoroughly for additional damage from mold, mildew, and pests. In the South half of the crawlspace bulk water is also noted. The posts appear to be satisfactory. The SW corner of this crawlspace is the wall that has significant signs of pest damage from the outside. I was unable to determine the extent of damage from the crawlspace. This area will be discussed further under the exterior walls portion. A new 6 mil black plastic vapor barrier needs to be added. Both of these crawlspaces need to have sump pumps added to keep water out. **Building 4145:** 5-6 posts along the West elevation set on grade that does not have an angle of repose that meets the minimum standards of 45 degrees. This means that the concrete pier posts are at risk for movement and failure. There is some evidence already that the piers have moved. A structural engineer should also evaluate this area prior to purchase or repairs. There is bulk water in North half of crawlspace at the SE corner. Footings in this crawlspace will not allow water to access low point drain, some trenching will be needed to void water properly. Approx 6" of water noted. The South portion of crawl space has 100 percent bulk water. A Sump pump will be needed to address situation and possibly some trenching. Approx. 40 percent of the 4x4 support posts have sustained damage and need to be replaced. Vapor barrier needs to be replaced. **Building 4147:** Sump pump is needed in both areas. Bulk water noted approx. 3-4" deep all through crawlspace. South is dryer than North, but both need addressed. **Building 4151:** Bulk water noted in crawlspace at the North elevation. Consider adding a sump pump. **Building 4153:** Bulk water noted at the NE corner of South access. Rot damage noted to SE corner stud wall. Siding needs to be removed and checked for how extensive the damage is. Unable to tell from crawlspace, I would expect significant damage given the visible signs of pest damage. Remove all wood debris from crawlspace. Remove dead cat that is in crawlspace. **Building 4155:** Leak at copper water line stub (hose bib) out noted at the NW access. Currently leaking. repairs recommended. **Building 4159:** Water noted at north access hatch, but dry underneath the units. In the SW access 1 4x4 post is leaning and needs to be re-set and shimmed. This post is at the North elevation of the SW access right along the foundation wall. Monitor crawlspace during periods of heavy rainfall and check for bulk water in crawlspace. It is dry now. **Building 4161:** Standing bulk water noted throughout the crawlspace. Moisture stains noted on posts. Unable to inspect crawlspace due to bulk water. Water was too deep to inspect the crawl space. As is the case with all bulk water have a drainage contractor evaluate and provide a positive drain system to keep crawl space dry at all times. **Building 4163:** Signs of past moisture in the crawlspace. Monitor during periods of heavy rainfall to ensure crawlspace stays dry during the winter. Re-hang fallen insulation. **Building 4165:** Re-hang insulation under the West access. Limited access at the East due to dead carcass at access entry. Paw prints noted on vapor barrier. Remove dead carcass and nested animal.

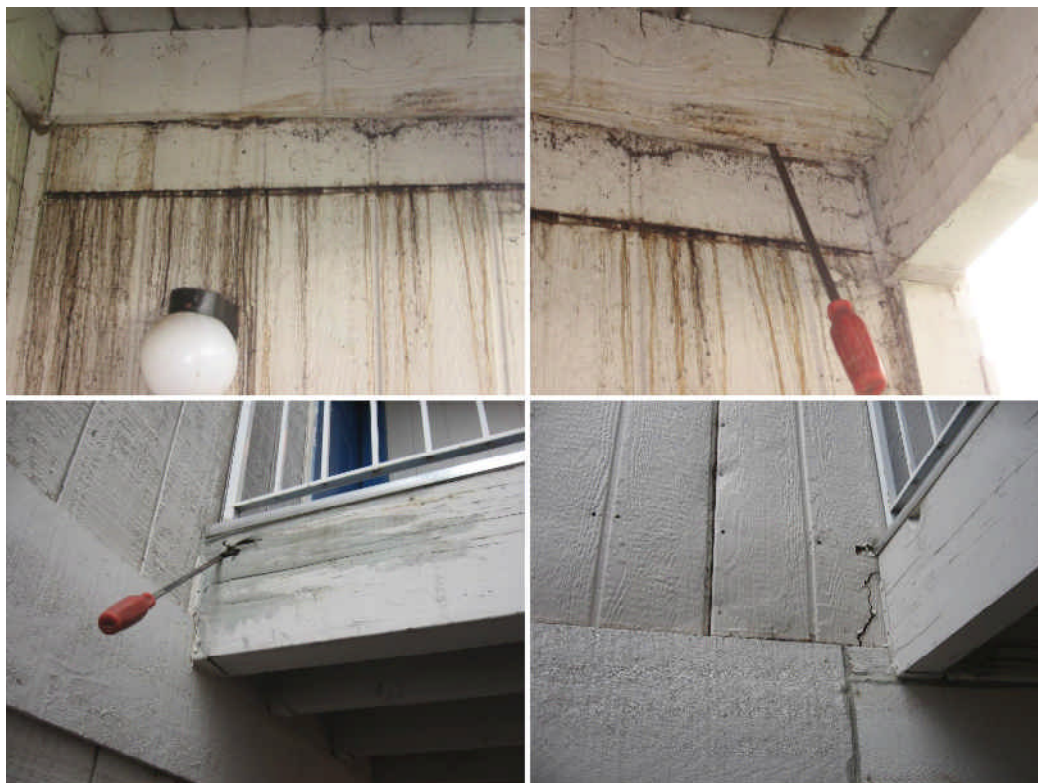
Extremely Poor condition. Siding was put on without the benefit of a vapor barrier. This has increased the potential for hidden damage; siding application without the proper vapor barrier is a recipe for moisture intrusion. Buyer has negotiated to have all 16 buildings re-sided by a licensed siding contractor. In our opinion, all of the siding has failed, and should be replaced. The digital camera work should give you an understanding of **extensive damage due to rot or pests**. We recommend that a representative amount of siding removed, and further evaluation to be done to determine if additional rot or pest damage exists to stud walls and/or deck framing. Each building was inspected individually. After careful evaluation of all the exterior siding, we found that approximately 90 percent of the siding shows signs of rot damage, improper repairs, and improper flashings. **Extensive rot and/or pest damage exists to approximately 70 percent of this siding.** We strongly recommend that **all the siding be removed** and interior stud walls be checked for hidden damage. Based on our visual findings, we have reason to believe that extensive hidden rot and/or pest damage exists. It is impossible to tell how extensive the rot and/or pest damage is the siding has been removed and the stud walls are exposed. Areas are noted where extreme rot and pest damage to exterior stud walls can be seen from the outside, but the amount of rot and total cost for repairs will be difficult to calculate until all the siding has been removed. Termite wings and damage were found at a few different areas, we

will not know how extensive this damage is until the siding has been removed. Areas noted like unit #60, and building #4143 where significant termite damage is visible would suggest extensive interior wall and stud damage. The visible evidence under all the decks (water stains and bowed siding) suggest that there will be significant rot and pest damage in these areas; the full extent of the damage can not be determined unless the siding is removed around these decks.

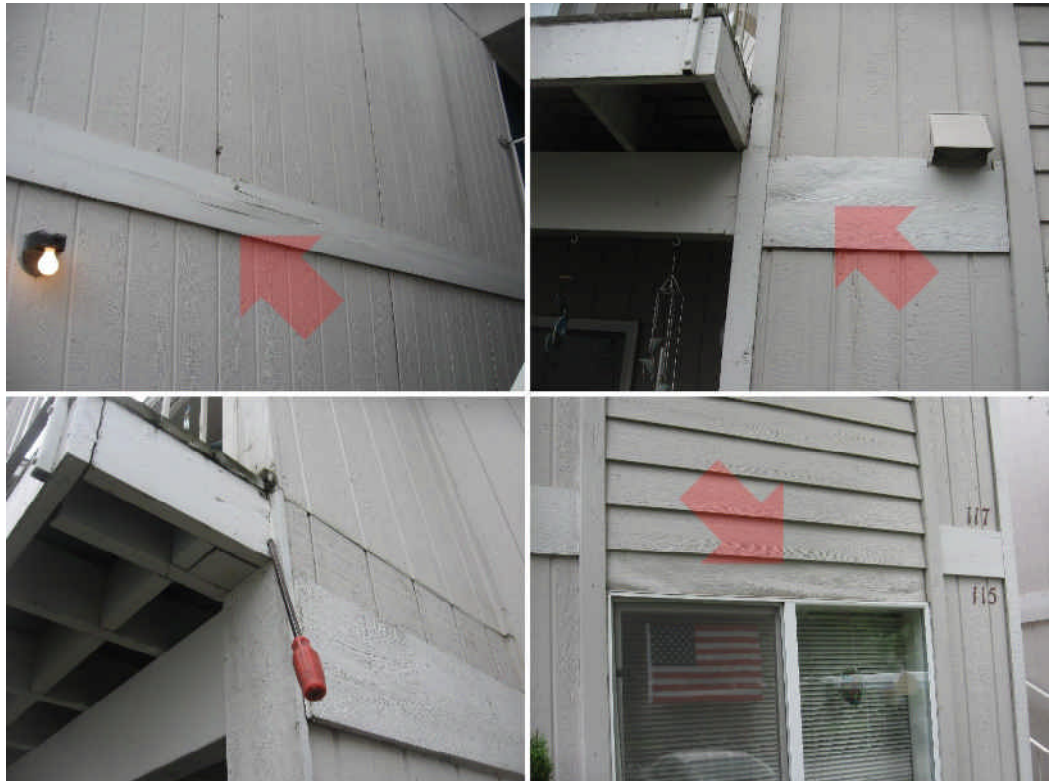
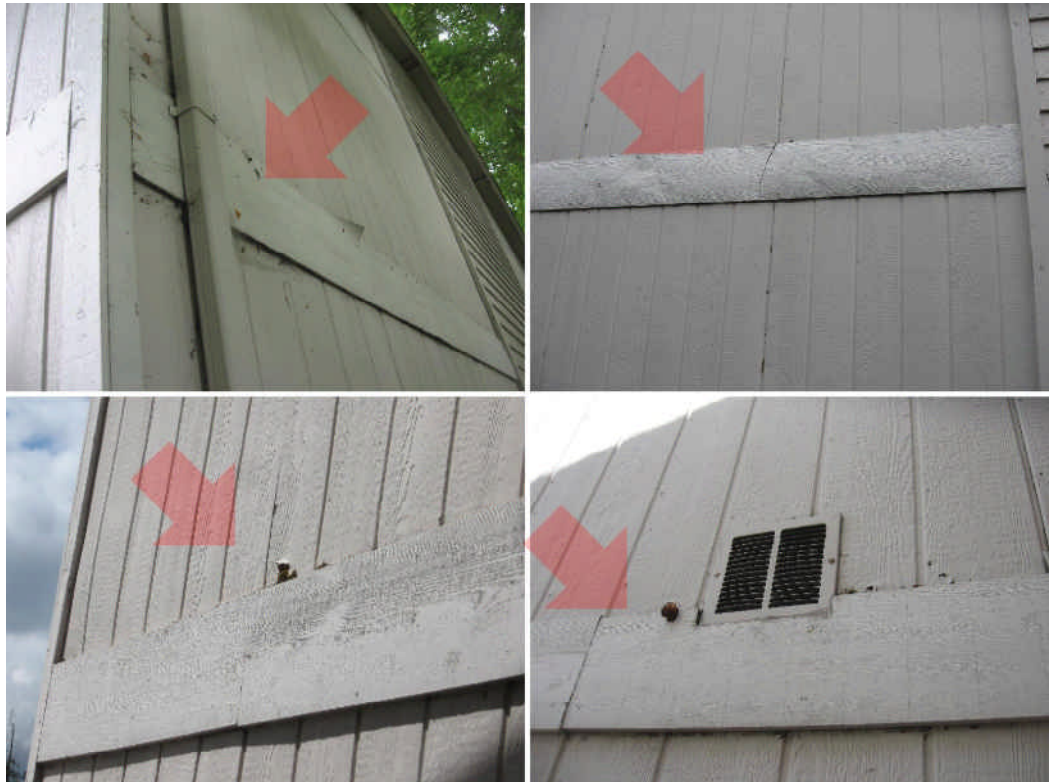
Significant rot and/or pest damage is noted to exterior joists, beams, and siding of decks. We anticipate that with the amount of rot damage and moisture intrusion visible from the exterior that extensive repairs will be needed. Each of the decks substructure and stud walls located behind ledger boards are at high risk for extensive hidden rot damage due to the excessive amount of moisture intrusion which can be seen from the exterior. We recommend that all areas around the decks have the siding removed and checked thoroughly for hidden rot and pest damage. The only way to be sure how much hidden damage exists is to completely open up areas around decks. Expect significant damage and repairs to almost all decks. Remove carpet from deck #99, unable to inspect.

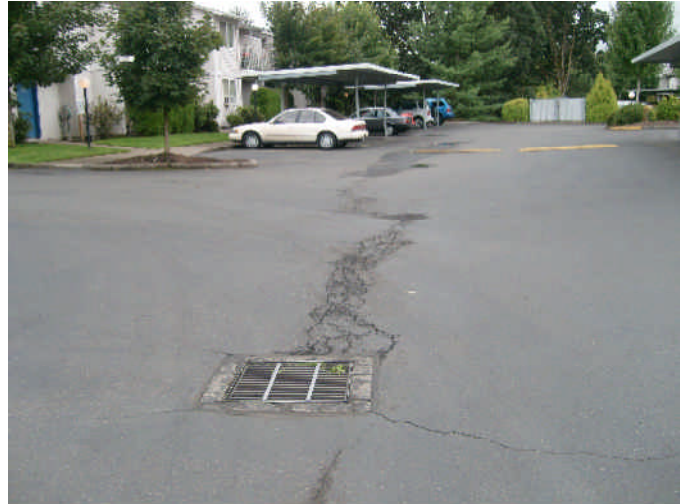
Fair. Some expansion cracking is present. Normal for aged materials. Some **repairs** will be needed around storm drain between building 4139-4141.

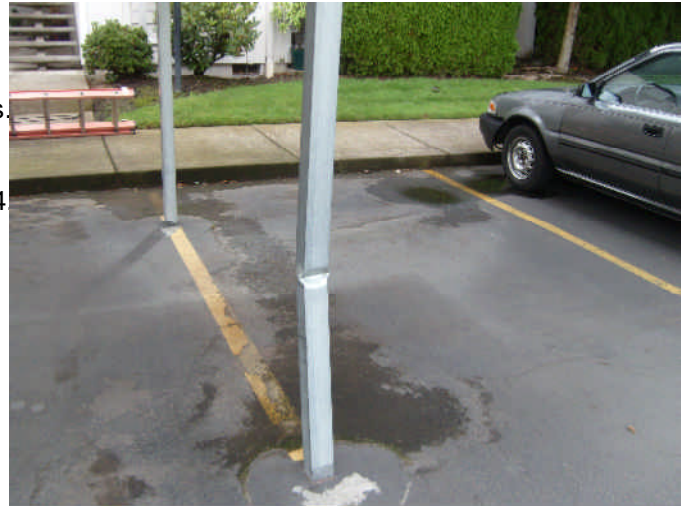
Good. Metal posts with galvanized metal roofing. Viewing was restricted on some of the roofs due to trees. **Significant damage** noted to metal pole for the carport between parking spots #43-44. This needs to be replaced in the near future.

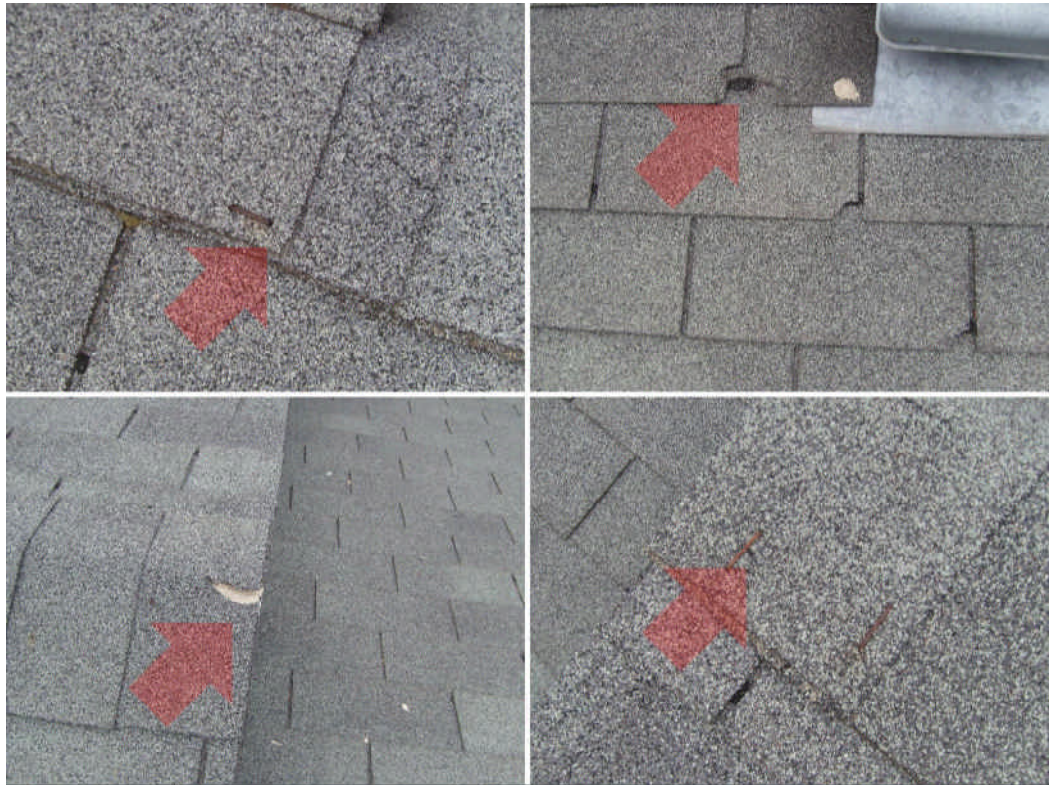
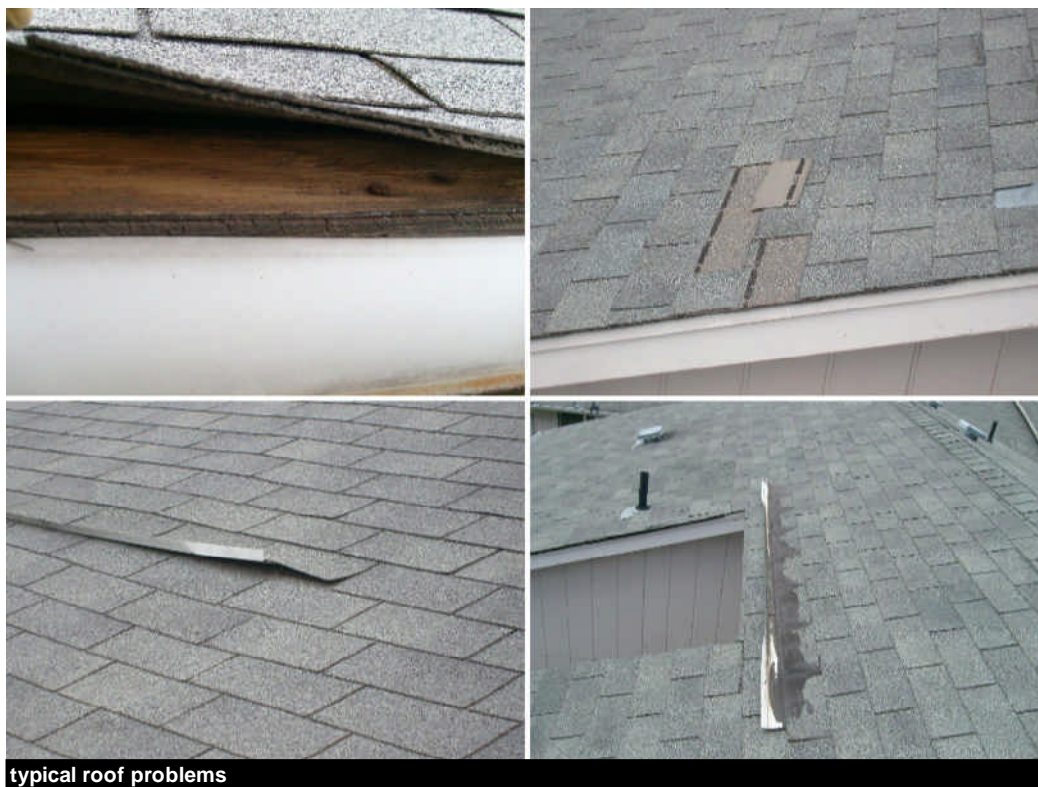
Fair, Approx. 14 +/- years old. Overall roof coverings show normal weathering commensurate with its age. Roof shows signs of granulation loss to its surface, with some areas exposed to accelerated weathering. None of the roofs were flashed properly at the eaves, the felt paper was cut back approx 5" with no starter course. We recommend that the eaves be properly flashed when the roofs are re-done. De-Moss all the roofs. Tree limbs are contacting the roof surfaces in quite a few different areas and should be trimmed off. All the roofs showed signs of past patching and we recommend that these all be maintained and monitored each year to keep roofs from leaking. With roofs this age, regular maintenance each year will be important and necessary. All issues discussed in this report should be evaluated and repaired by a **licensed roofing contractor**. Each building was inspected independently and the issues for each are as follows: **Building 4131**: Missing shingles, areas of past patching noted. Monitor. Roof has 3-5 years of remaining life left. **Building 4133**: Laundry room floor is missing entire ridge cap. This needs to be repaired ASAP. Missing shingles noted. Past patching noted and need to monitor. Roof appears to have 3-5 years left. **Building 4135**: Missing shingles, past patching needs to be monitored. 3-5 years left. **Building 4137**: Softness and deflection noted to roof between units 30-32 at the entry walk way. It appears that some sheathing has sustained damage and will need to be replaced when the roof is re-done. This roof appears to have 3-5 years of remaining life left. Some repairs will be needed each year. **Building 4139**: Past patching noted that needs to be monitored. Wasp nest noted under metal pipe vent flashing around unit #36. Roof appears to have 3-5 left. **Building 4141**: Laundry room roof needs to be de-mossed at the NW elevation. Wall to roof transition for the laundry room roof needs to be re-done, signs of moisture intrusion behind siding. Individual roof tabs at the West elevation have started to lift up and some additional flashing may be needed at this area to keep moisture intrusion out. Roof appears to have 3-5 years of remaining life left. **Building 4143**: Prior patching noted and needs to be monitored. Exposed fasteners noted at the

ridge cap, these need to be caulked. Damaged shingles noted that are in need of replacement at the ridge cap and in the field. Roof appears to have 3-5 years of remaining life left. **Building 4145:** Previous patching noted next to eaves, it appears from wind damage. Monitor. Roof has 3-5 years of remaining life left. **Building 4147:** Patched shingles noted. Missing shingles noted at the NE corner that need to be replaced. Roof appears to have 3-5 left. **Building 4151:** Roof has 3-5 years left. **Building 4153:** Past patching noted. missing shingles noted that need replacement. Roof has 3-5 left. **Building 4155:** Missing shingles noted and need to be replaced. Roof has 3-5 years remaining. **Building 4159:** Horizontal stress cracks noted to the individual roof tabs. Significant signs of patching noted at the SW corner. Damaged shingles noted at the SE corner. Repairs are needed. Roof appears to only have 1-2 years of life left. **Building 4161:** Missing shingles, and prior patching noted. Monitor. (This roof has more like 2-3 years left of remaining life.) **Building 4163:** Black jack patching noted above both entry walkways. These areas need to be monitored frequently and kept patched. (This roof has 2-3 years left of serviceable life.) **Building 4165:** Uplifted flashings, soft spots, potential damaged roof sheathing, damaged shingles, and missing shingles all noted above unit #122. Past patching and caulk is noted and needs to be monitored. Roof appears to have 3-5 years left. **Issues discussed in this report should be repaired immediately to keep roofs from potential leaks.**

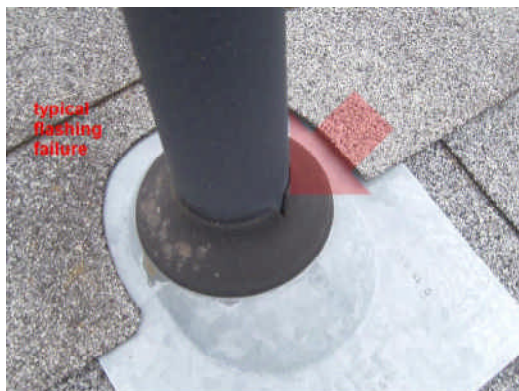
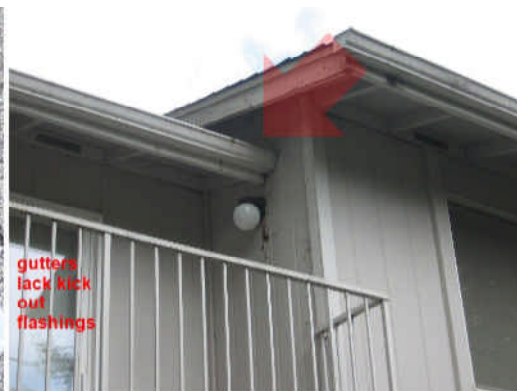
Rubber flashings at plumbing vent stacks are older showsigns of deterioration to approx. 70 percent of the pipe vent flashings; rainwater leakage potential is present. We recommend that buyer budget to replace all rubber flashings ASAP. There appears to be about 10 to 12 pipe vents per roof. Re-paint all gable end flashings. Missing kick-out flashings are noted at all the wall to gutter transitions. These flashings help direct and void all rainwater into the gutters. Not having the proper kick-out flashings present at all the transitions is allowing water to get behind the siding and run down the exterior walls. A licensed roofing contractor should evaluate and add kick-out flashings to all transitions when the buildings are re-sided to prevent this from happening in the future.

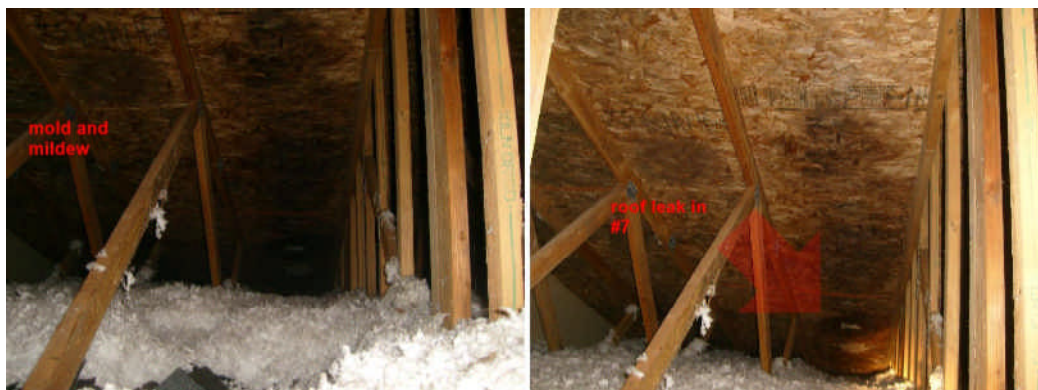
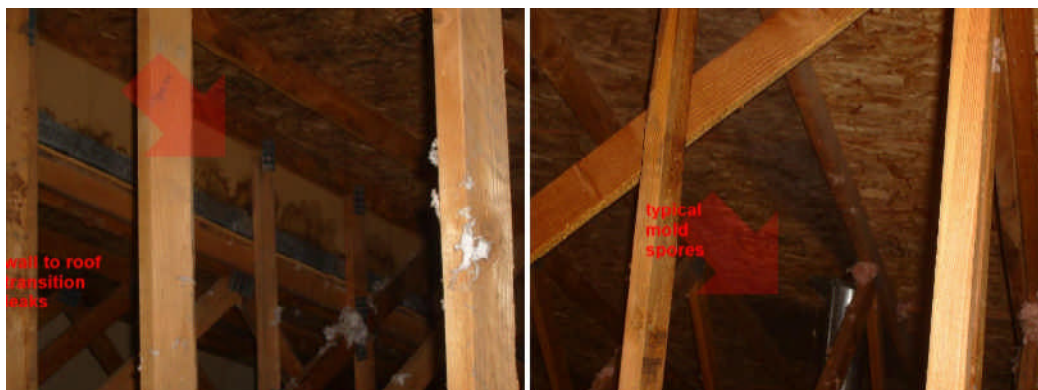
The following units showed signs of leaks and/or mold and mildew at the following areas: #32, 40- minor signs of mold/mildew noted, #36- significant signs of moisture stains noted at the wall to roof transition, #75- mold/mildew noted around kitchen vent, #7- leak and mold around pipe vents, significant amount of sheathing damage noted. #63- leak around pipe vent, 57 & 60- mold/mildew noted, #56- leaks noted at the wall to roof transitions. Flashings have failed. 113 & 114- minor mold/mildew noted, #43 & 44- minor mold and mildew, #96- attic shows signs of leaking at vent for kitchen range, #47 & 48- moisture stains noted at wall to roof transitions, flashings have appeared to fail. #51 & 52- mold and mildew noted. #31- roof leaks around vent for range, and it appears that some roof sheathing has sustained some damage at this area. Mold and mildew also noted. ,
